Inspection Report

Property Address:
12345 Undisclosed Address
Rockville MD 20853

The Pearce Group

Date: 2/22/2013	Time: 03:30 PM	Report ID:
Property: 12345 Undisclosed Address Rockville MD 20853	Customer: Mr. Alex Smith	Real Estate Professional: Terry Hall remax

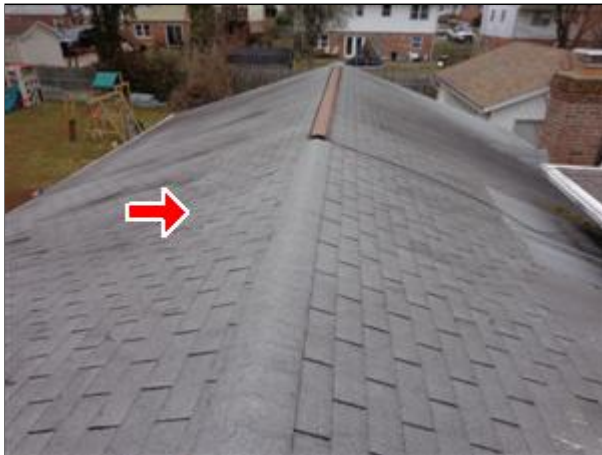
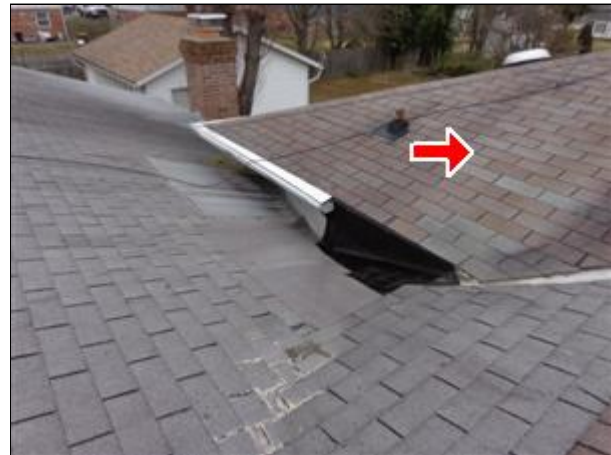
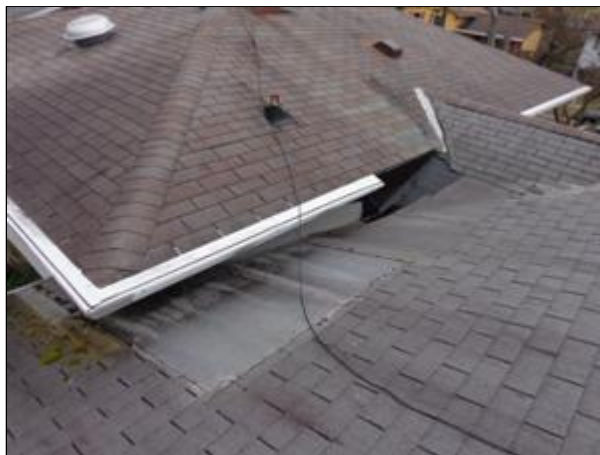
1.0 (1) The rear roof surface is 3 tab shingle with a normal life of 20 years. The current age is approximately 20 years old and is reaching the end of its useful life. Budget to replace in the near future.

The front roof surface is 3 tab shingle with a normal life of 20 years. The current age is approximately 16 years old and is reaching the end of its useful life. Budget to replace in the near future.

1.0 Picture 1 older addition roof

1.0 Picture 2 newer main roof

1.0 Picture 3 top view

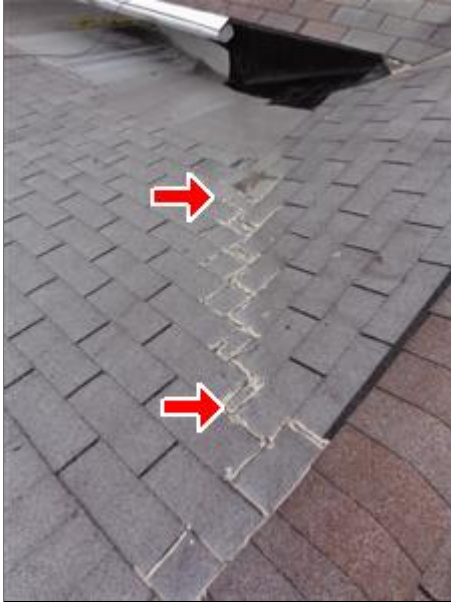
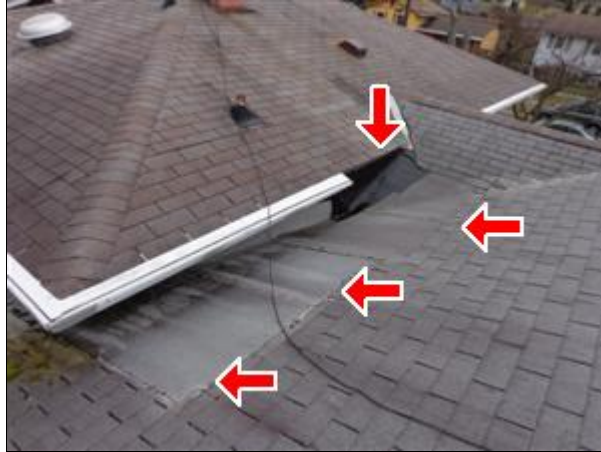
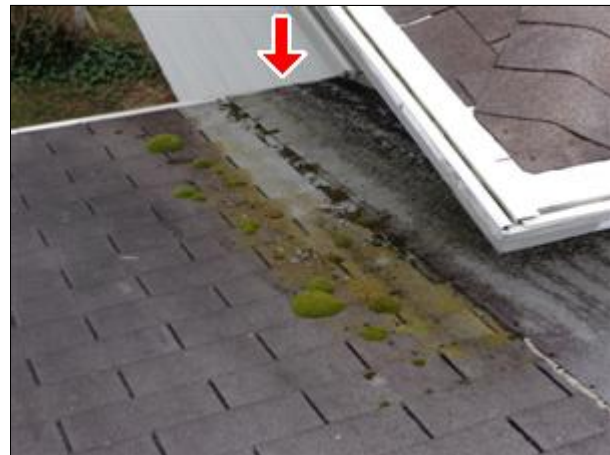
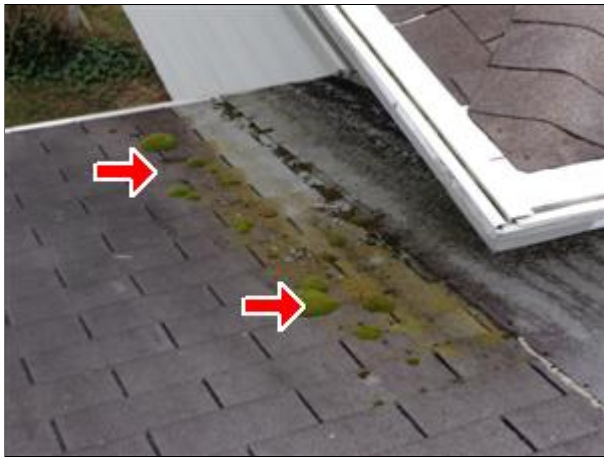
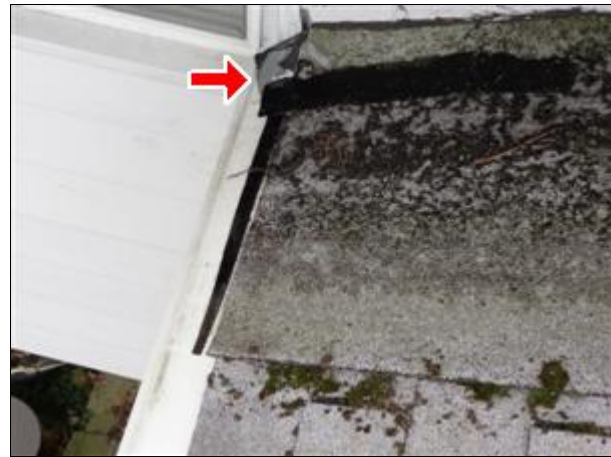
(2) The connection of the main roof of home and the addition is awkward. The route the water takes is under the eave of the original main roof surface. Also the valley at this area is rolled roofing material with a normal life of 12-15 years much less than the 3 tab shingles. Over the years patch work is visible in this area to prevent leaks in the valleys at several locations. Although no leaks were observed at this time it would be best to replace this area with new roofing material without joints or seams. Alternatively you could rework the roofs valley and pitches to carry water off the roof in a less awkward manor.

1.0 Picture 4 repairs to valley

1.0 Picture 5 rolled roofing this area

1.0 Picture 6 water can get trapped under eave

1.0 Picture 7 patch work here

1.0 Picture 8 remove fungus on roof surface

1.0 Picture 9 patch work at gutter rear of home

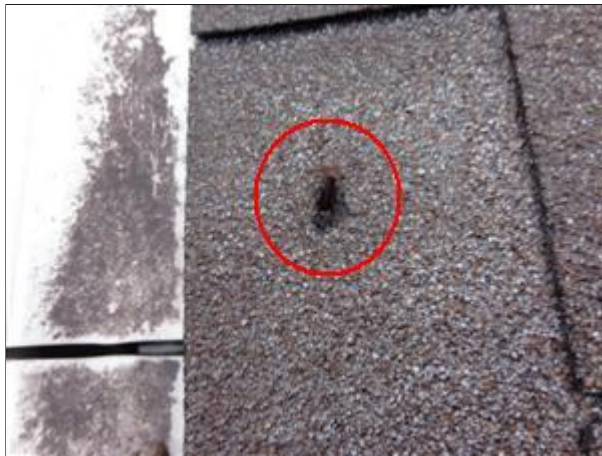
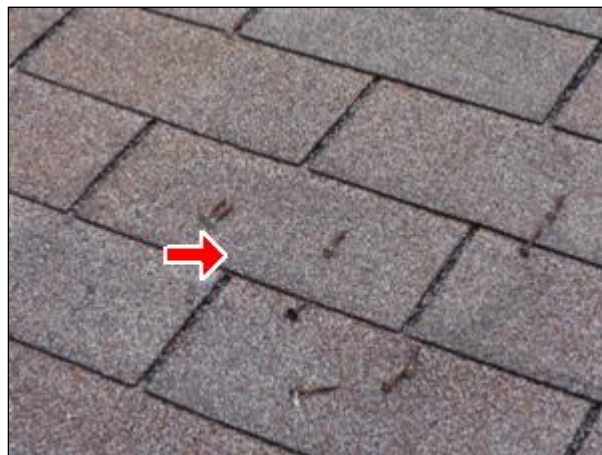
(3) On the front roof surface I observed many areas where nails were put through the face of the shingle to attach the gutter guards. These areas should be tarred over to prevent leakage. Also remove all loose nails left from repairs over the years that can puncture the roof surface.

1.0 Picture 10 nail head

1.0 Picture 11 nail heads

1.0 Picture 12 loose nails on roof

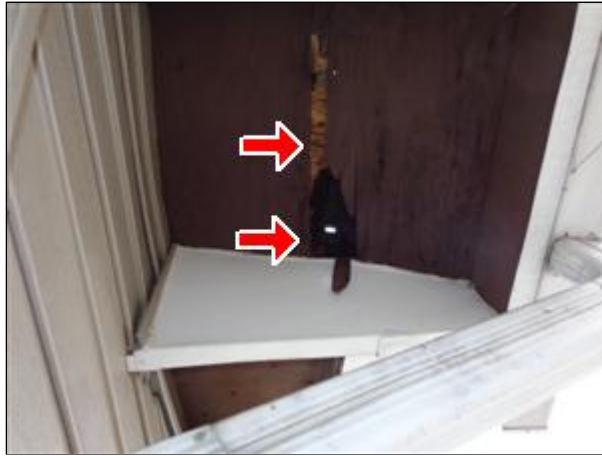
(4) The left side of homes soffitt has a hole visible from underneath at the valley. Have this roofing material removed the wood repaired and the shingles re-installed. Due to this condition being in the eve water has not entered the home only thru the soffitt onto the concrete outside.

1.0 Picture 13 hole light visible

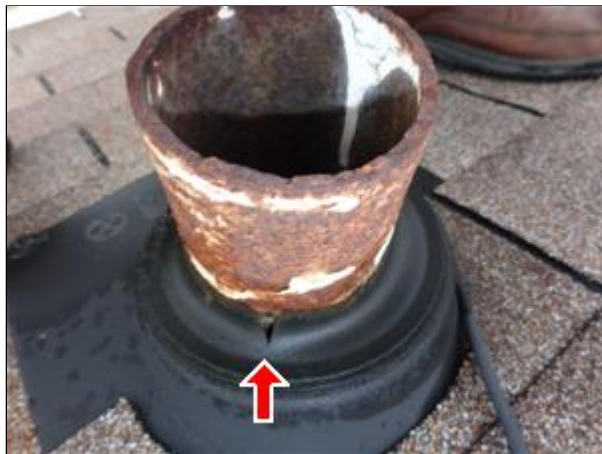
1.1 The rear of home has several flashing boots that go around the plumbing vents. These boots are made of rubber and over time dry out and crack. No leaks were observed but they are currently cracked and may allow water entry as this progresses. Have a contractor install roof tar to help prolong the life and prevent leaks.

1.1 Picture 1 voids here

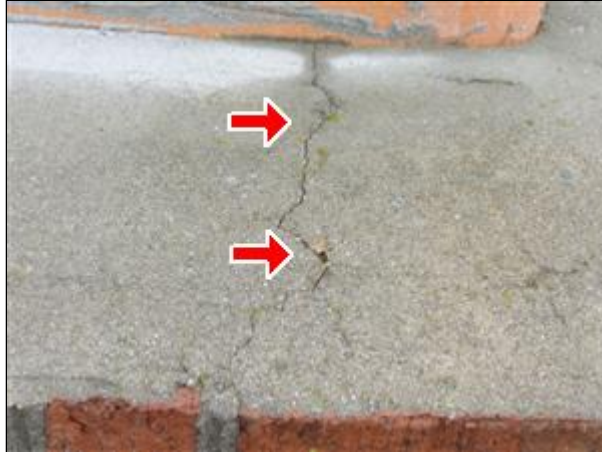
1.2 The chimney crown mortar is cracked and allows water entry. This water freezes and expands and causes damage to the brick of the chimney. Have a mason evaluate and repair chimney crown as needed.

1.2 Picture 1 fill these voids

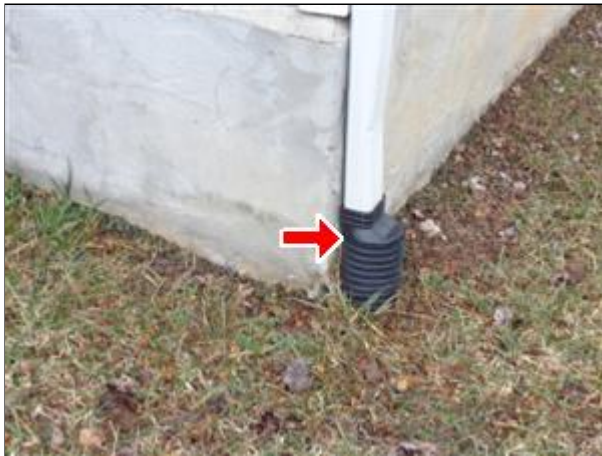
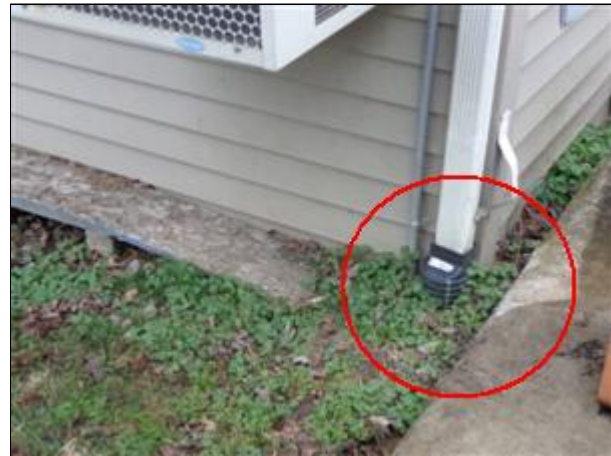
1.3 The garage and homes downspout goes underground to an unknown location. I recommend monitoring these drains to assure the water does not back up off the roof and go down the foundation wall and into the basement. If this backs up I recommend cutting off and day-lighting to a splash block where it can be watched and monitored.

1.3 Picture 1 at garage

1.3 Picture 2 main house

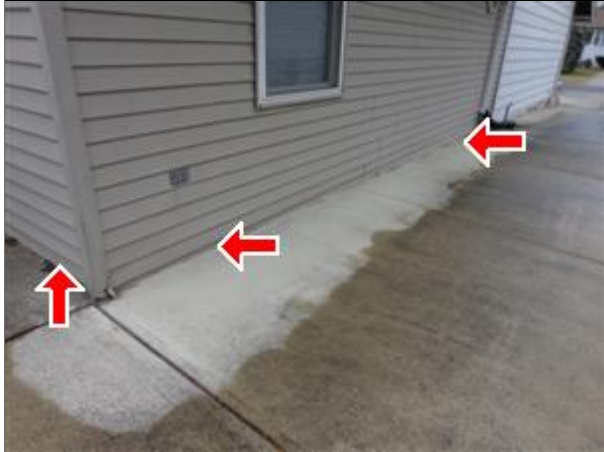
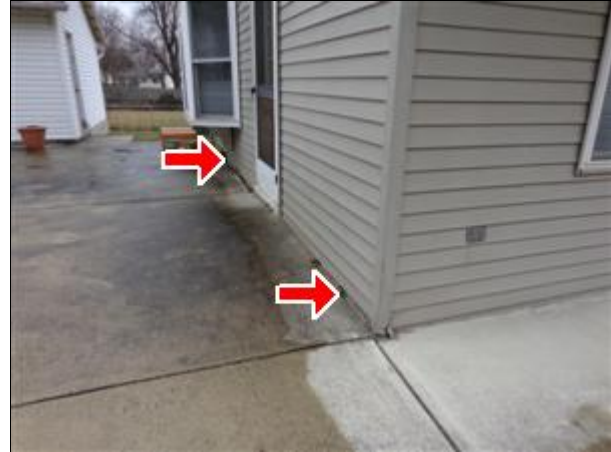
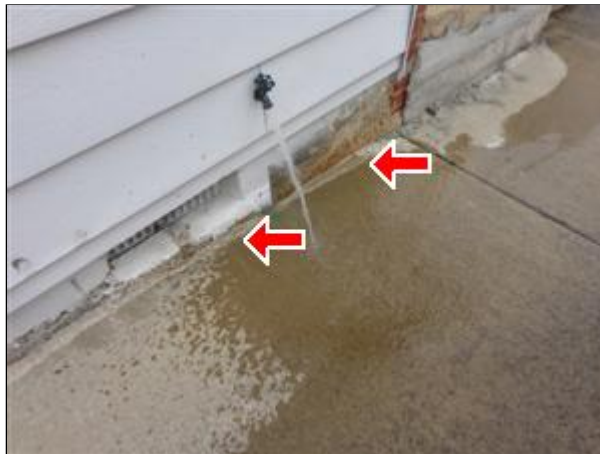
2.0 (1) Siding is in contact with ground at left side and rear addition of the home. Because the siding is in contact with ground it is possible for framing to be deteriorated below grade. We did not inspect behind this siding as it is not possible unless building material is removed. Its preferred that a pressure treated bottom plate on a outside wall sit at least six inches above ground level on a masonry product ie block or poured foundation wall. This condition also prevents insects like termites to more easily access the wood framing of the home without being detected. If the wall sits on masonry a termite would have to build a mud tube on outside of wall as they cannot not be exposed to air which would be easily observed.

2.0 Picture 1 left side and rear ground contact

2.0 Picture 2 rear of home

2.0 Picture 3 water moves back toward home

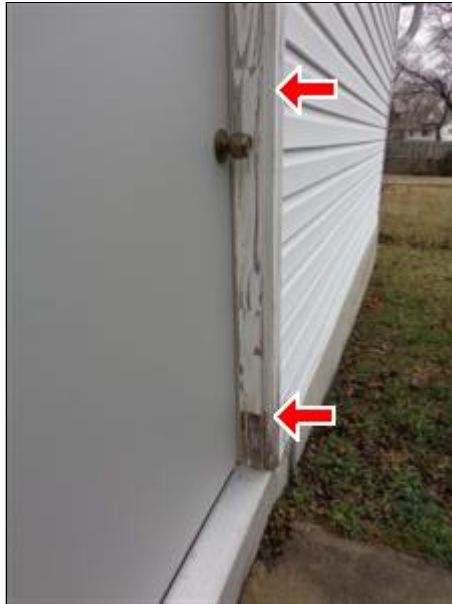
(3) I observed many areas around the exterior of the home where trim and door need scrape/sanding then a fresh coat of paint. Bare wood becomes exposed to the elements and if not protected will rot over time.

2.0 Picture 4 rear garage door

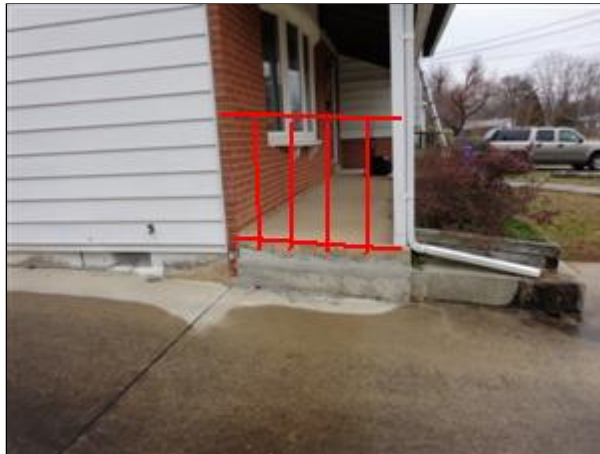
2.3 (1) Its recommended when more than two steps are present or a greater than twelve inch drop is present a handrail be installed. Consider adding one to the left side front porch to improve safety.

2.3 Picture 1 add handrail or steps

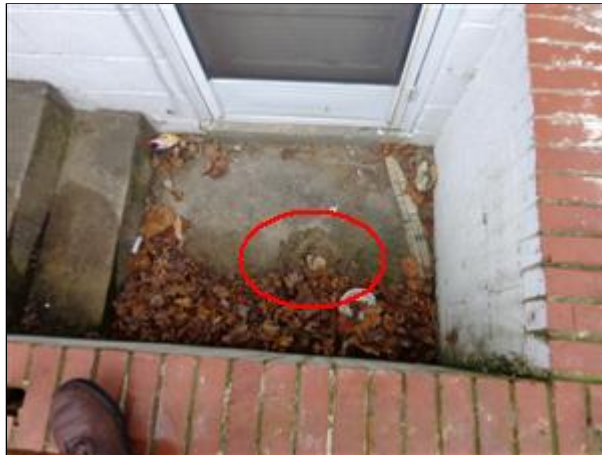
(2) A clogged areaway drain is one of the top five reasons for a flooded basement according to the Insurance Institute. Be sure to keep the areaway clear of leaves and debris and consider covering with a screen.

2.3 Picture 2 drain here

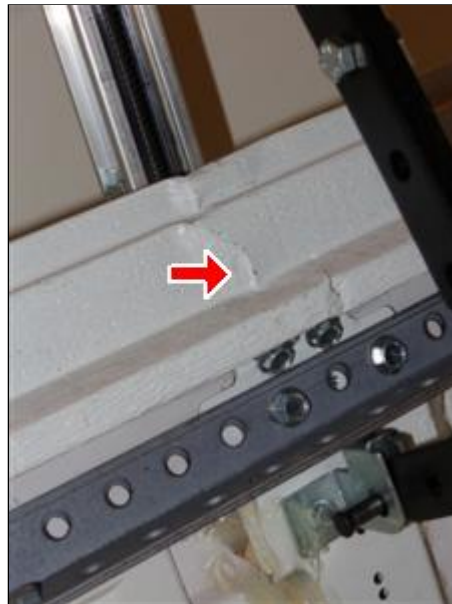
3.2 The metal garage door is split at the center attachment of lift motor. Repairs consist of adding angle iron to this area to help prevent further damage.

3.2 Picture 1 split here

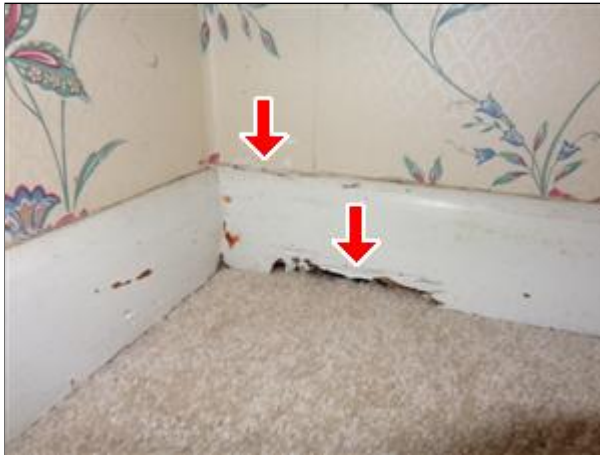
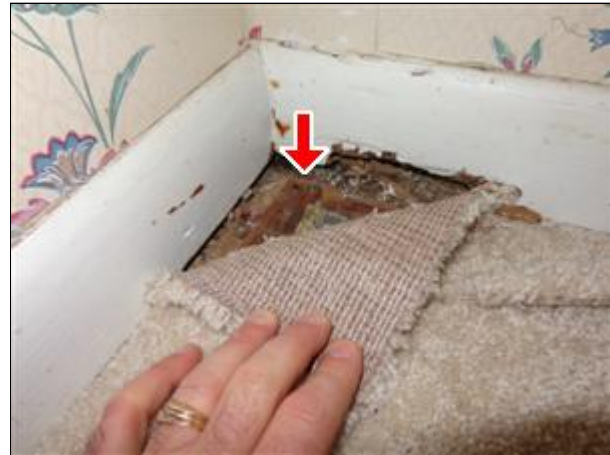
4.1 Older termite damage was observed at the trim right front corner of the home. Its no possible to determine the extent of damage unless the drywall is removed.

4.1 Picture 1 termite damage to trim

4.1 Picture 2 view with carpet pulled back

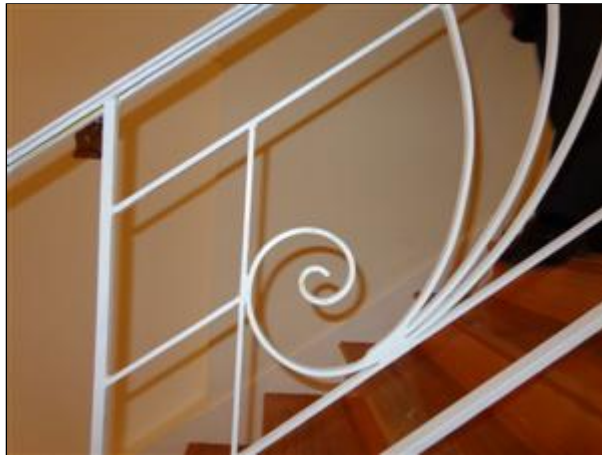
4.3 The space between pickets is greater than four inches wide which is a hazard to children and pets. Although this may have been code when the home was built we recommend adding netting available at baby stores to prevent accidental falls.

4.3 Picture 1 open spaces

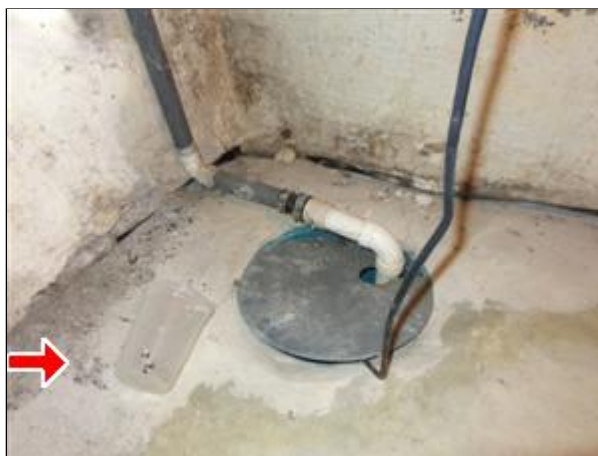
5.0 (1) A perimeter drain system was installed in the crawl space of home . This system is a retrofit to solve a chronic water issue in the past. A trench is dug around the interior foundation in which stone and drain tile is installed then concreted over to close floor. Any water that enters the foundation flows along the pipe to a sump pit where it's pumped outside the home. This system must be monitored and you may consider adding a battery back up in the event of power failure the pumps wont work.

A dehumidifier is running in the crawl space to control humidity level and its old. I recommend keeping this unit running to lower humidity in the crawl space.

5.0 Picture 1 drain tile under floor

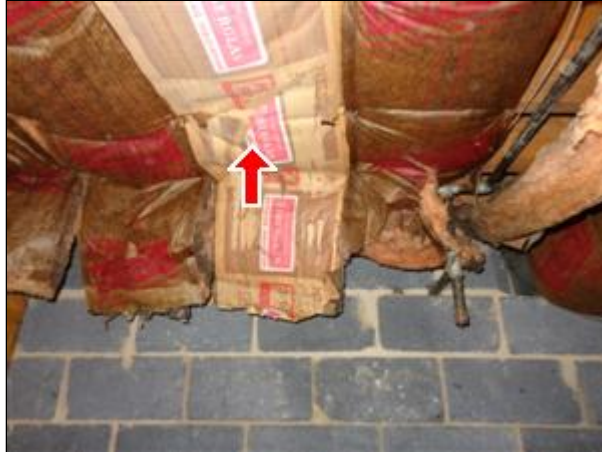
(2) The crawl space should have insulation with a vapor barrier installed against the heated side of the floor. In this crawl

space the vapor barrier is down which can trap moisture between the floor causing fungal growth and rot. Have the paper removed or new insulation installed properly.

5.0 Picture 2 paper should be against floor

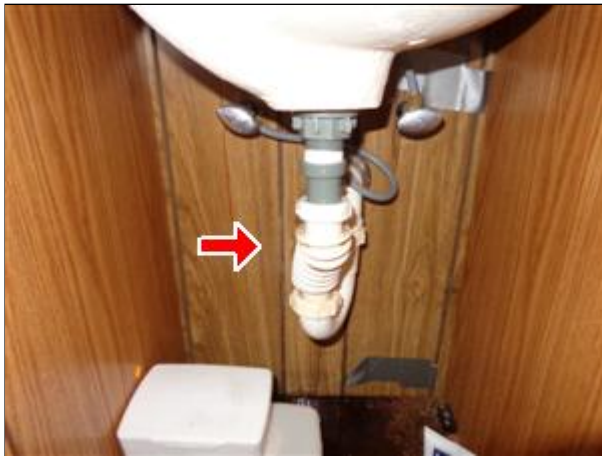
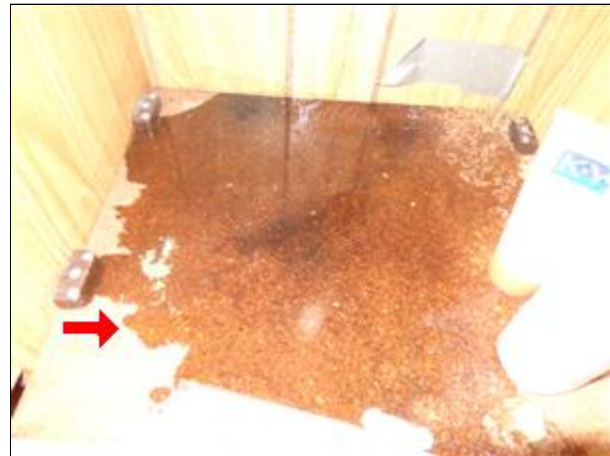
(2) The sink trap under basement bathroom sink second floor is leaking. Have a plumber evaluate and repair as needed.

6.7 Picture 1 leaks here

6.7 Picture 2 water leak from testing drain

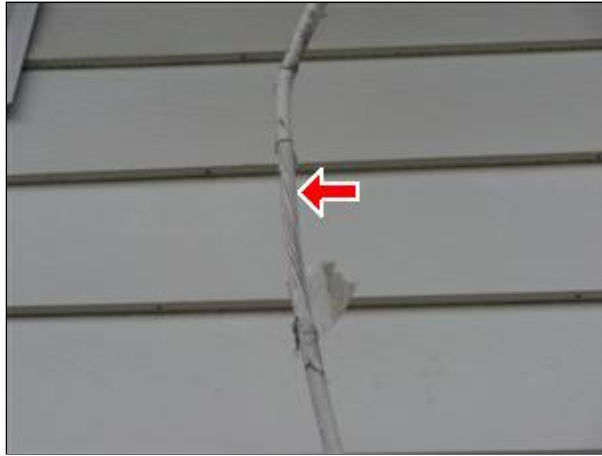
7.0 The electrical service conductors have a fabric outer coating that is frayed at wire sheathing outside. This helps protect the conductors that are inside. The conductors are covered with a thick coating of rubber and this is not a shock hazard but you may consider wrapping with electrical tape to help protect the wire and keep water from running down the wire and entering the panel.

7.0 Picture 1 wires frayed here

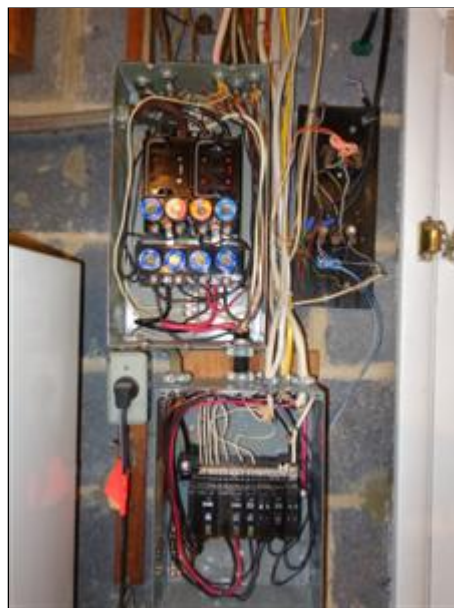
The breakers in this panel in several locations have two wires under one breaker screw. This condition is commonly referred to as a "double tap" The condition can lead to overloaded circuits but in and of itself does not necessarily mean a code violation exist. Seek a licensed electricians opinion and repair.

The main panel consist of no single main breaker as required in modern panels. Also it uses twist type fuses as opposed to modern breakers which can be reset if an overload occurs. I recommend having an electrician evaluate and install a modern 200 amp breaker type panel.

7.1 Picture 1 view of both panels

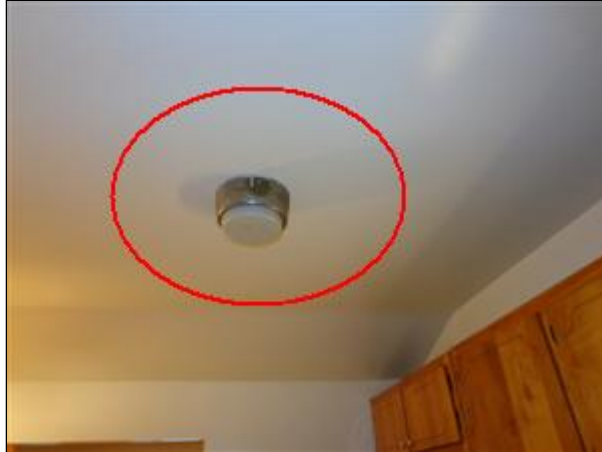
7.3 The kitchen light was not operational. This could be as simple fix (replace bulb) or a more serious issue requiring a licensed electrician. Have repaired replaced as needed.

7.3 Picture 1 light out

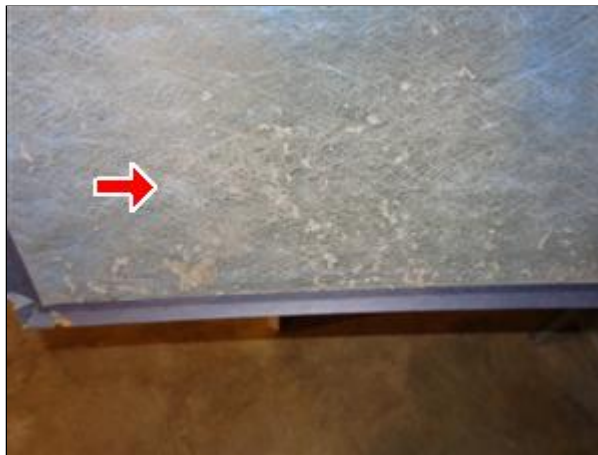
8.1 The 16x25 Filter is dirty and needs replacing in basement unit.

8.1 Picture 1 filter dirty

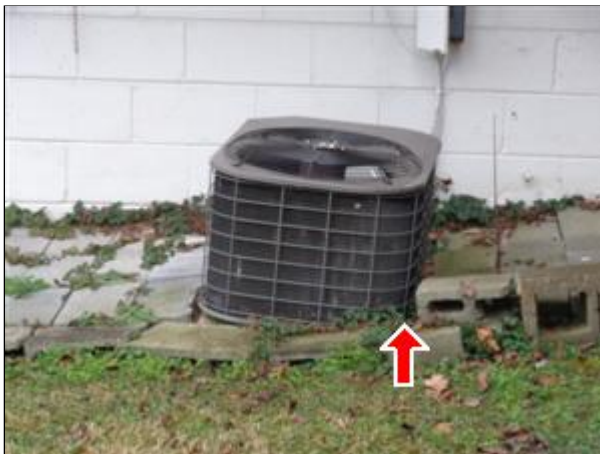
(2) The A/C unit is slightly out of level. Its recommended by the manufacturer that the unit be level since oil is stored in the bottom of the compressor. Level slab as needed by removing or adding dirt.

8.5 Picture 1 raise up

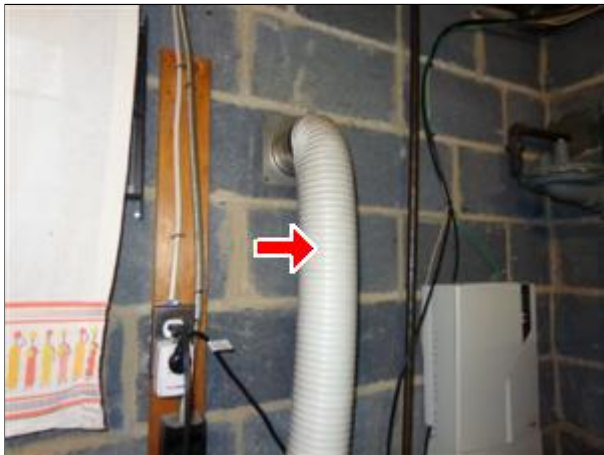
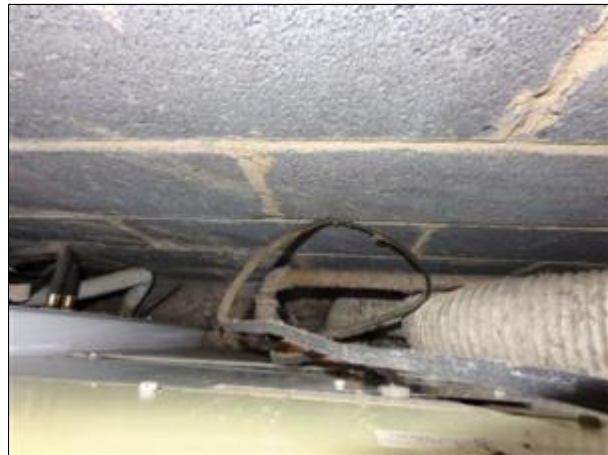
9.2 The gas clothes dryer vent is required to be made of metal with a smooth interior finish for proper venting. Currently a flex vent is being used which can trap lint and leak condensation and flue gases out of the vent. Consider replacing with a proper pipe.

9.2 Picture 1 flex vent

9.2 Picture 2 connection behind dryer
