Inspection Report

Property Address:
12345 Undisclosed Address
Rockville MD 20853

The Pearce Group

Date: 2/22/2013	Time: 03:30 PM	Report ID:
Property: 12345 Undisclosed Address Rockville MD 20853	Customer: Mr. Alex Smith	Real Estate Professional: Terry Hall remax

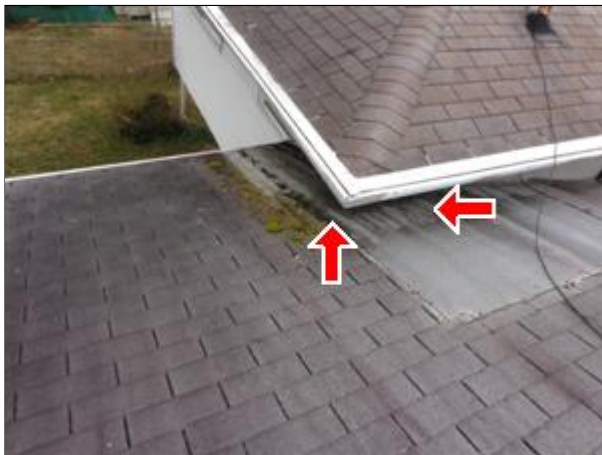
(2) The connection of the main roof of home and the addition is awkward. The route the water takes is under the eave of the original main roof surface. Also the valley at this area is rolled roofing material with a normal life of 12-15 years much less than the 3 tab shingles. Over the years patch work is visible in this area to prevent leaks in the valleys at several locations. Although no leaks were observed at this time it would be best to replace this area with new roofing material without joints or seams. Alternatively you could rework the roofs valley and pitches to carry water off the roof in a less awkward manor.

1.0 Picture 6 water can get trapped under eave

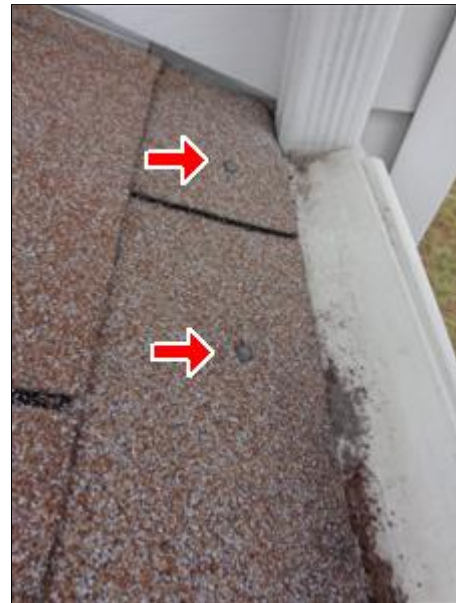
(3) On the front roof surface I observed many areas where nails were put through the face of the shingle to attach the gutter guards. These areas should be tarred over to prevent leakage. Also remove all loose nails left from repairs over the years that can puncture the roof surface.

1.0 Picture 11 nail heads

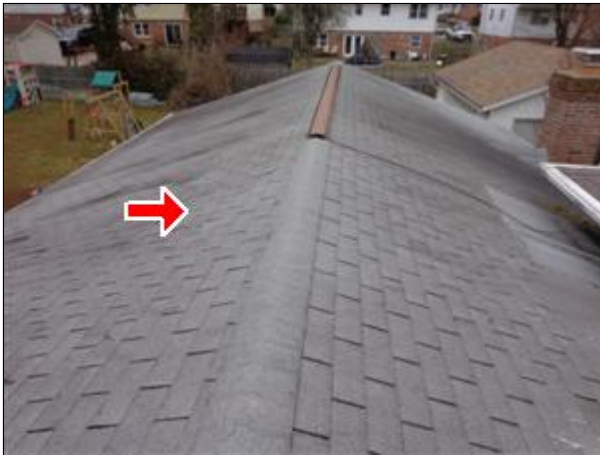
(1) The rear roof surface is 3 tab shingle with a normal life of 20 years. The current age is approximately 20 years old and is reaching the end of its useful life. Budget to replace in the near future.

1.0 Picture 1 older addition roof

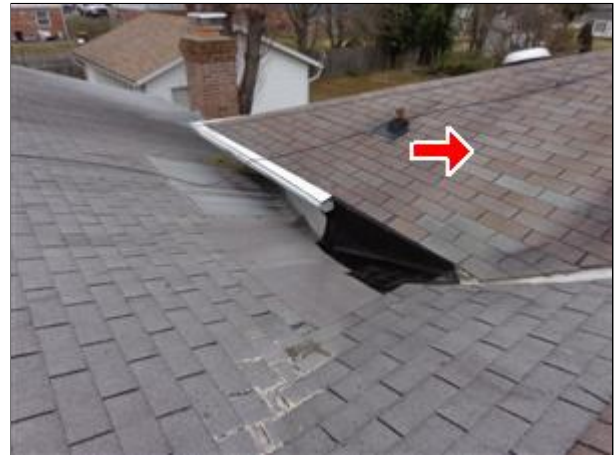
The front roof surface is 3 tab shingle with a normal life of 20 years. The current age is approximately 16 years old and is reaching the end of its useful life. Budget to replace in the near future.

1.0 Picture 2 newer main roof

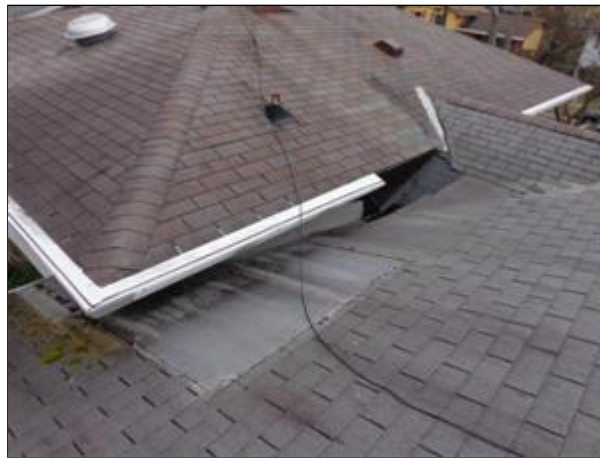
1.0 Picture 3 top view

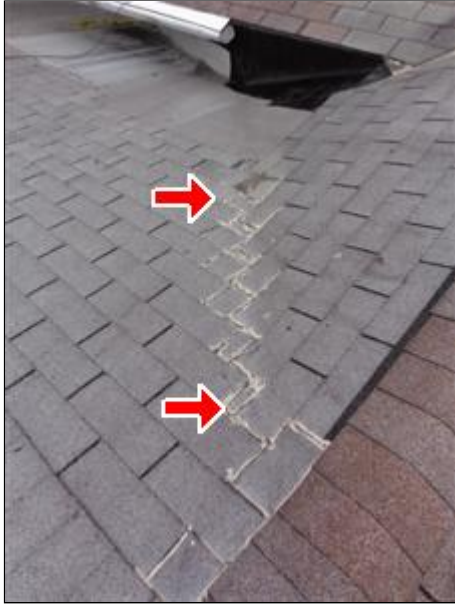
(2) The connection of the main roof of home and the addition is awkward. The route the water takes is under the eave of the original main roof surface. Also the valley at this area is rolled roofing material with a normal life of 12-15 years much less than the 3 tab shingles. Over the years patch work is visible in this area to prevent leaks in the valleys at several locations. Although no leaks were observed at this time it would be best to replace this area with new roofing material without joints or seams. Alternatively you could rework the roofs valley and pitches to carry water off the roof in a less awkward manor.

1.0 Picture 4 repairs to valley

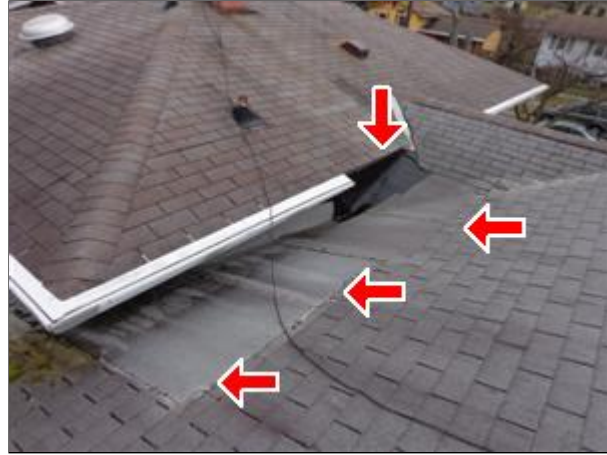
1.0 Picture 5 rolled roofing this area

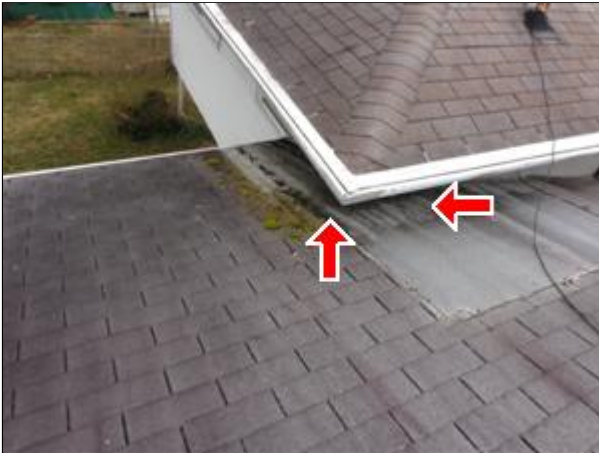
1.0 Picture 6 water can get trapped under eave

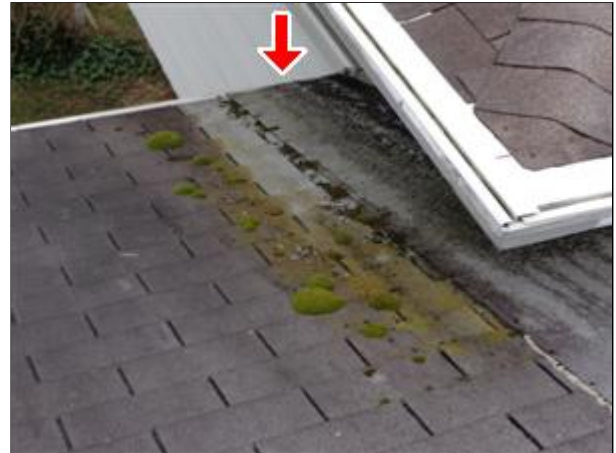
1.0 Picture 7 patch work here

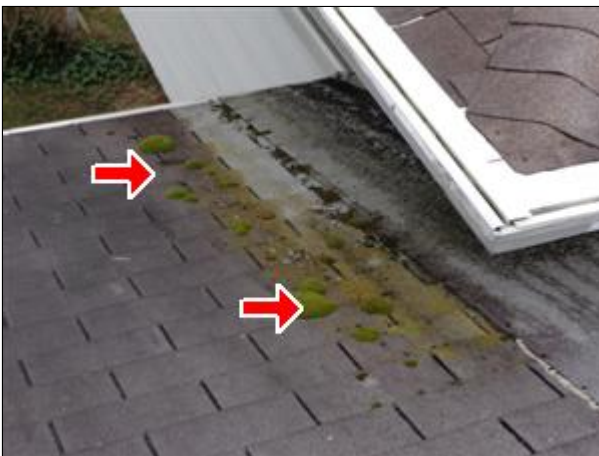
1.0 Picture 8 remove fungus on roof surface

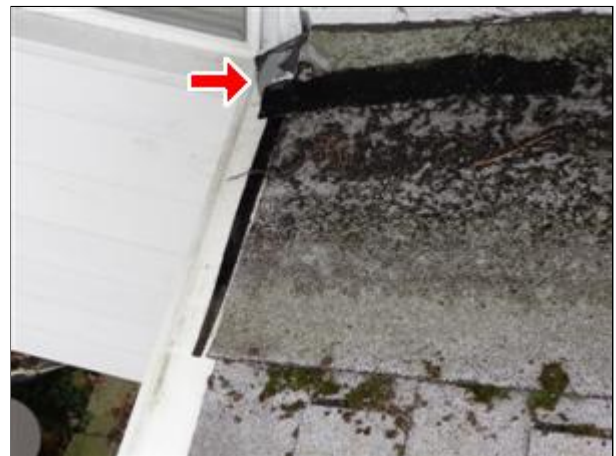
1.0 Picture 9 patch work at gutter rear of home

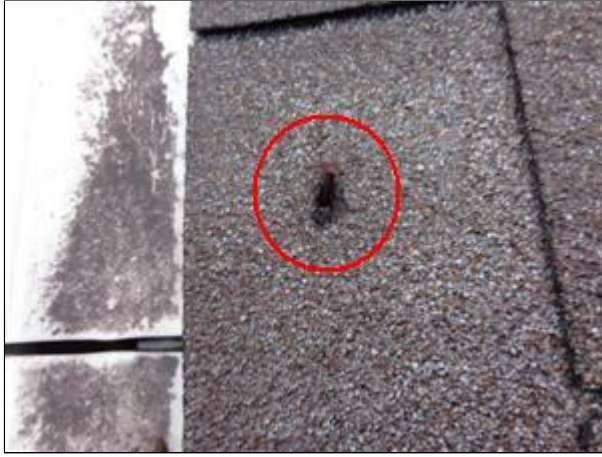
(3) On the front roof surface I observed many areas where nails were put through the face of the shingle to attach the gutter guards. These areas should be tarred over to prevent leakage. Also remove all loose nails left from repairs over the years that can puncture the roof surface.

1.0 Picture 10 nail head

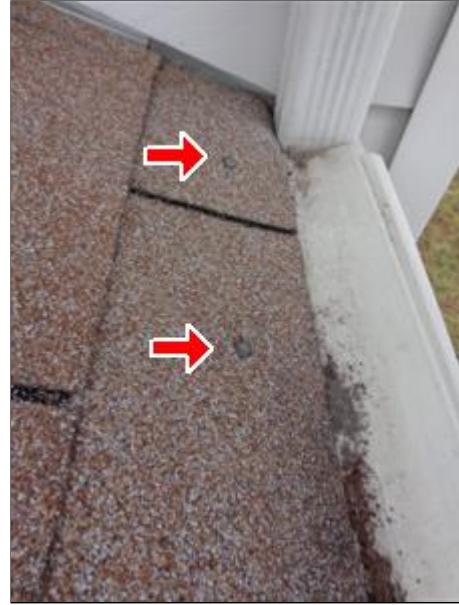
1.0 Picture 11 nail heads

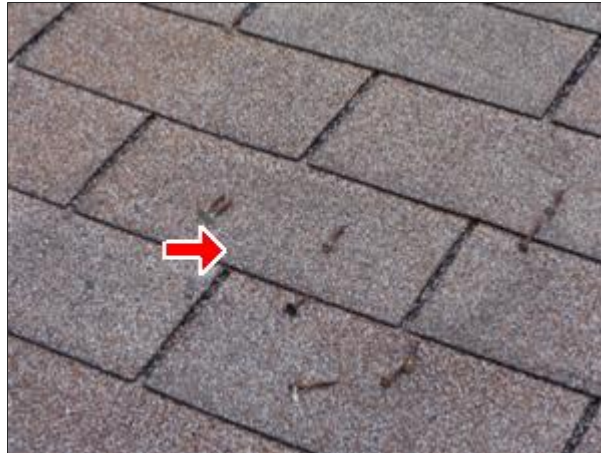
1.0 Picture 12 loose nails on roof

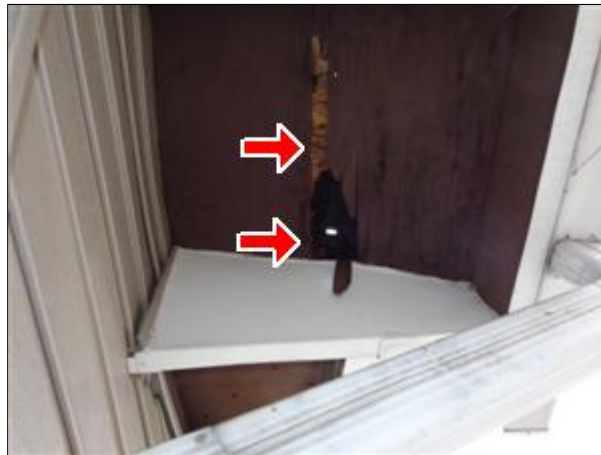
(4) The left side of homes soffitt has a hole visible from underneath at the valley. Have this roofing material removed the wood repaired and the shingles re-installed. Due to this condition being in the eve water has not entered the home only thru the soffitt onto the concrete outside.

1.0 Picture 13 hole light visible

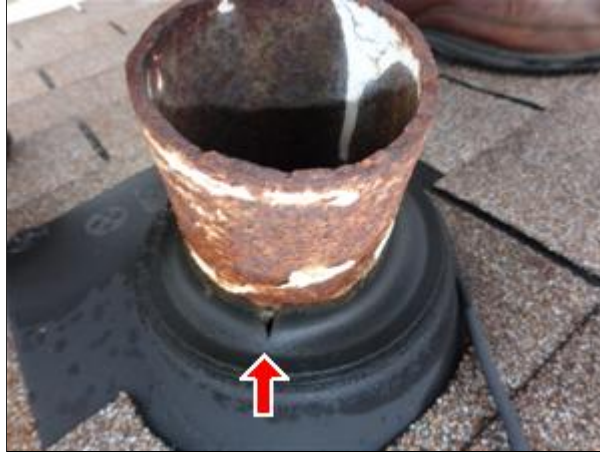
The rear of home has several flashing boots that go around the plumbing vents. These boots are made of rubber and over time dry out and crack. No leaks were observed but they are currently cracked and may allow water entry as this progresses. Have a contractor install roof tar to help prolong the life and prevent leaks.

1.1 Picture 1 voids here

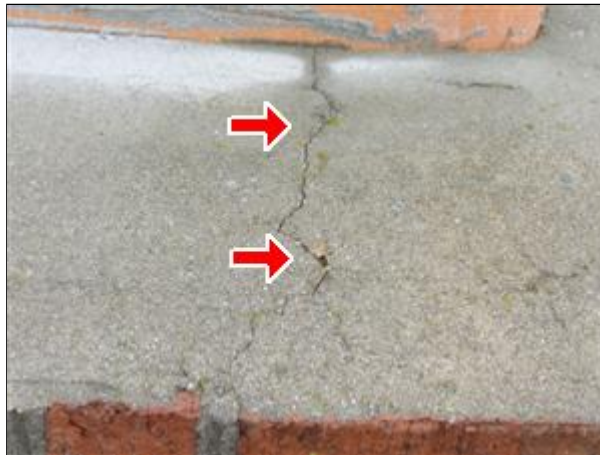
The chimney crown mortar is cracked and allows water entry. This water freezes and expands and causes damage to the brick of the chimney. Have a mason evaluate and repair chimney crown as needed.

1.2 Picture 1 fill these voids

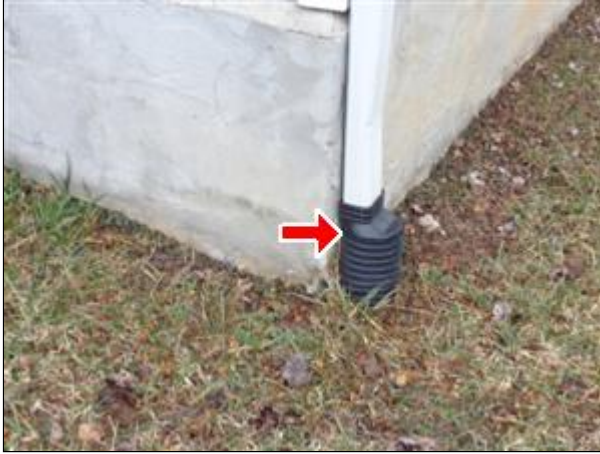
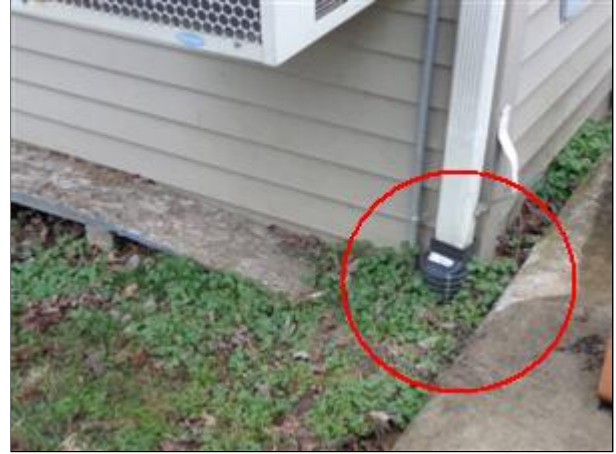
The garage and homes downspout goes underground to an unknown location. I recommend monitoring these drains to assure the water does not back up off the roof and go down the foundation wall and into the basement. If this backs up I recommend cutting off and day-lighting to a splash block where it can be watched and monitored.

1.3 Picture 1 at garage

1.3 Picture 2 main house

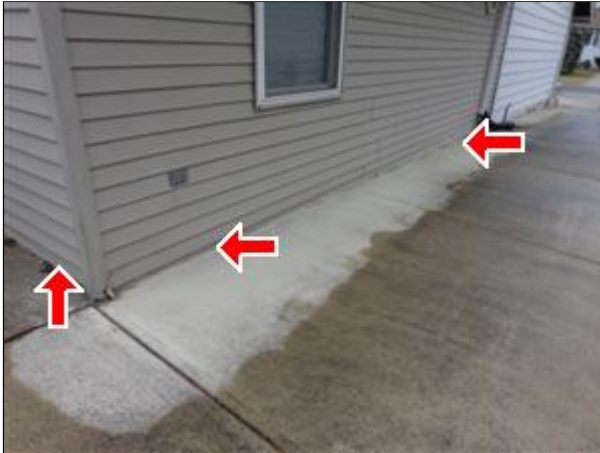
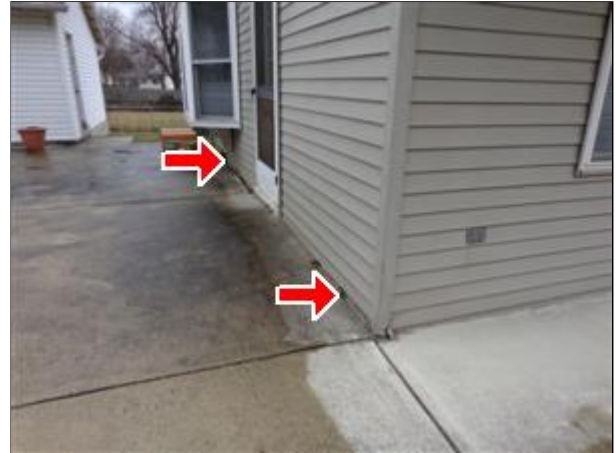
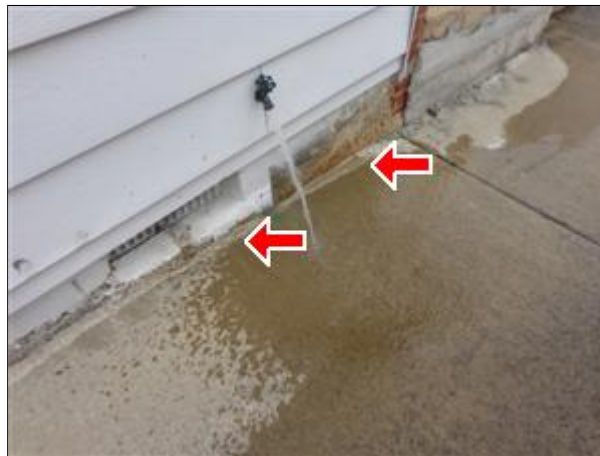
(1) Siding is in contact with ground at left side and rear addition of the home. Because the siding is in contact with ground it is possible for framing to be deteriorated below grade. We did not inspect behind this siding as it is not possible unless building material is removed. Its preferred that a pressure treated bottom plate on a outside wall sit at least six inches above ground level on a masonry product ie block or poured foundation wall. This condition also prevents insects like termites to more easily access the wood framing of the home without being detected. If the wall sits on masonry a termite would have to build a mud tube on outside of wall as they cannot not be exposed to air which would be easily observed.

2.0 Picture 1 left side and rear ground contact

2.0 Picture 2 rear of home

2.0 Picture 3 water moves back toward home

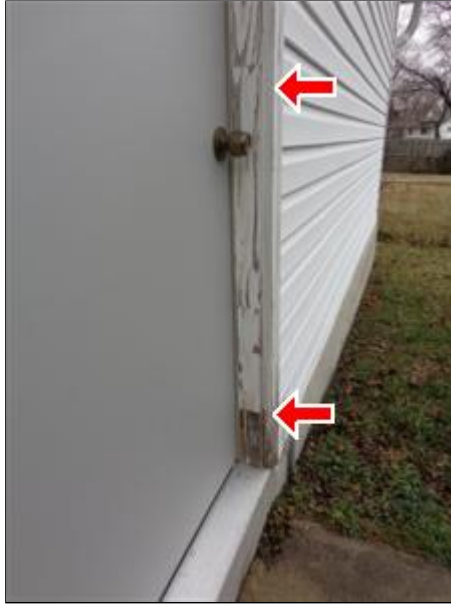
(3) I observed many areas around the exterior of the home where trim and door need scrape/sanding then a fresh coat of paint. Bare wood becomes exposed to the elements and if not protected will rot over time.

2.0 Picture 4 rear garage door

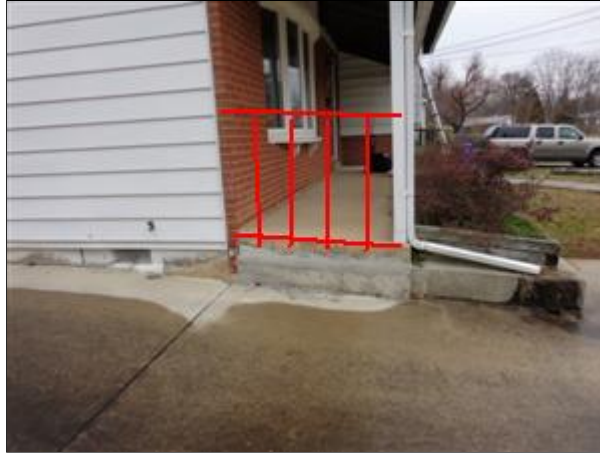
(1) Its recommended when more than two steps are present or a greater than twelve inch drop is present a handrail be installed. Consider adding one to the left side front porch to improve safety.

2.3 Picture 1 add handrail or steps

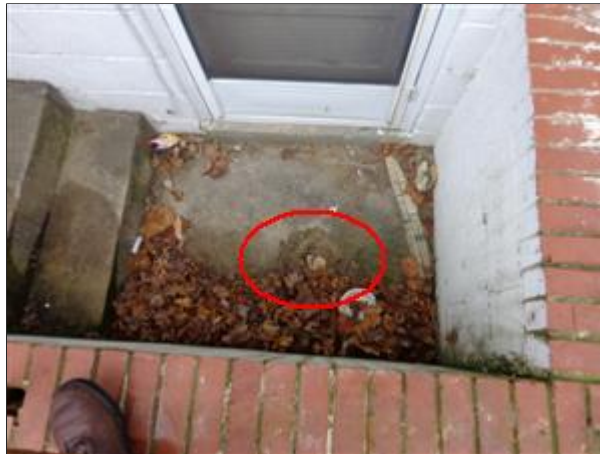
(2) A clogged areaway drain is one of the top five reasons for a flooded basement according to the Insurance Institute. Be sure to keep the areaway clear of leaves and debris and consider covering with a screen.

2.3 Picture 2 drain here

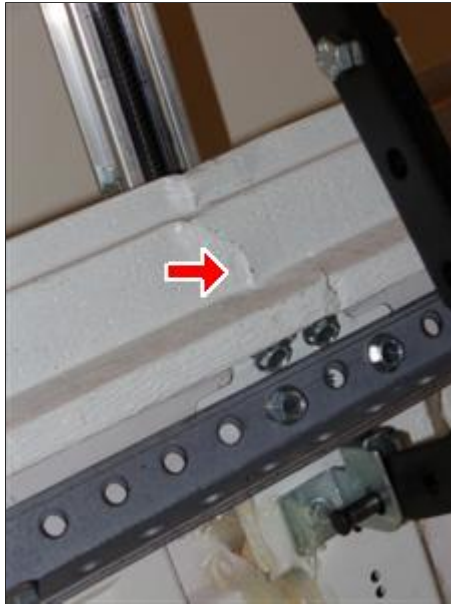
The metal garage door is split at the center attachment of lift motor. Repairs consist of adding angle iron to this area to help prevent further damage.

3.2 Picture 1 split here

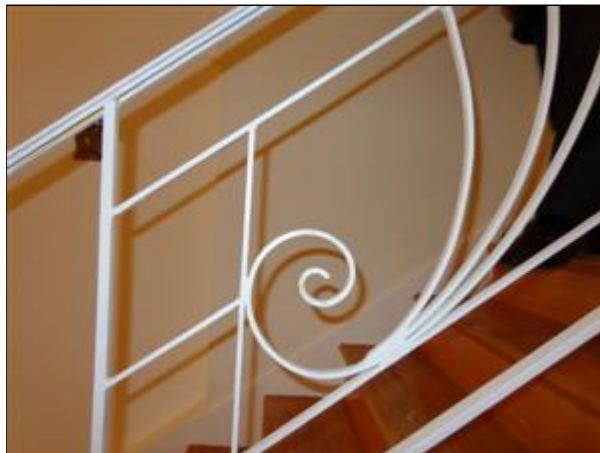
The space between pickets is greater than four inches wide which is a hazard to children and pets. Although this may have been code when the home was built we recommend adding netting available at baby stores to prevent accidental falls.

4.3 Picture 1 open spaces

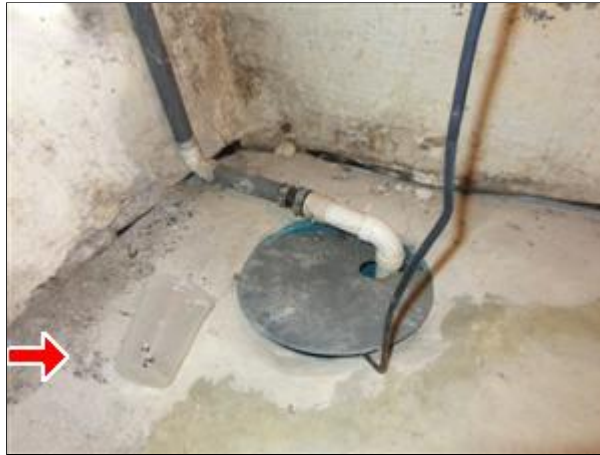
(1) A perimeter drain system was installed in the crawl space of home . This system is a retrofit to solve a chronic water issue in the past. A trench is dug around the interior foundation in which stone and drain tile is installed then concreted over to close floor. Any water that enters the foundation flows along the pipe to a sump pit where it's pumped outside the home. This system must be monitored and you may consider adding a battery back up in the event of power failure the pumps wont work.

A dehumidifier is running in the crawl space to control humidity level and its old. I recommend keeping this unit running to lower humidity in the crawl space.

5.0 Picture 1 drain tile under floor

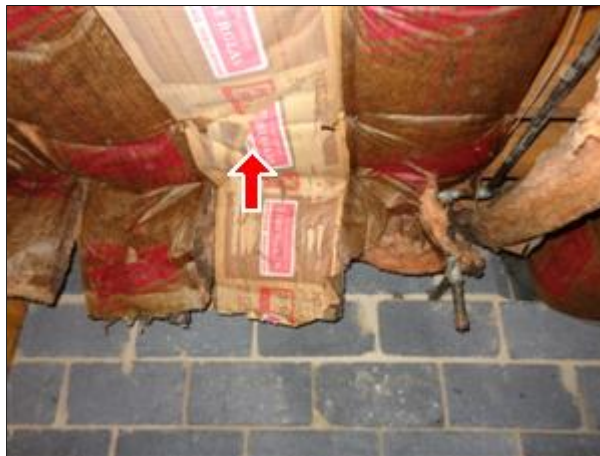
(2) The crawl space should have insulation with a vapor barrier installed against the heated side of the floor. In this crawl space the vapor barrier is down which can trap moisture between the floor causing fungal growth and rot. Have the paper removed or new insulation installed properly.

5.0 Picture 2 paper should be against floor

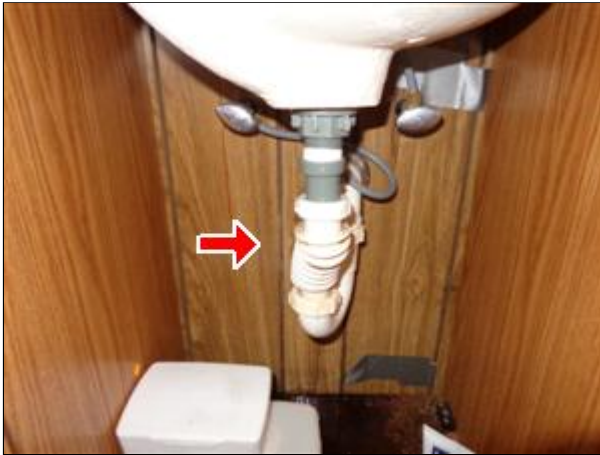
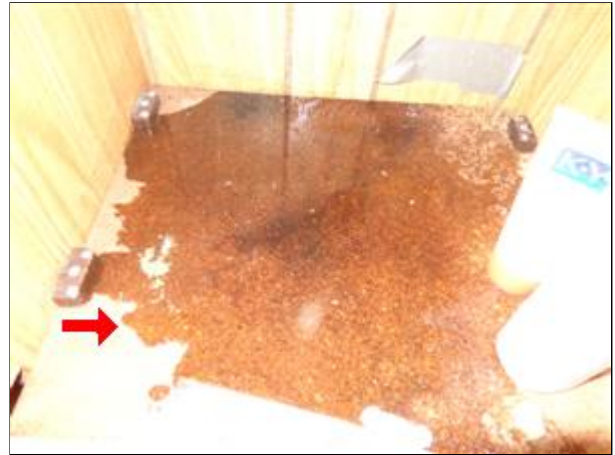
(2) The sink trap under basement bathroom sink second floor is leaking. Have a plumber evaluate and repair as needed.

6.7 Picture 1 leaks here

6.7 Picture 2 water leak from testing drain

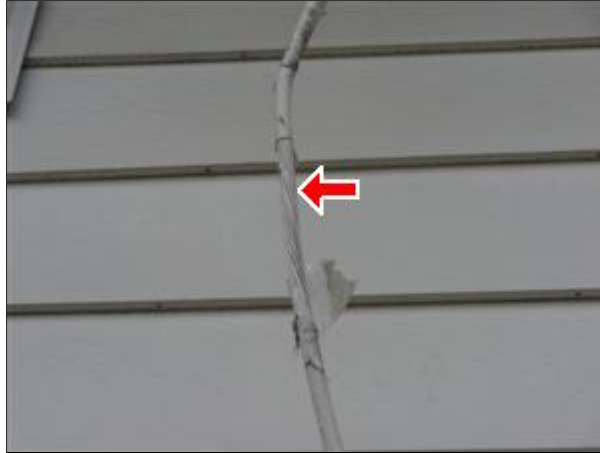
The electrical service conductors have a fabric outer coating that is frayed at wire sheathing outside. This helps protect the conductors that are inside. The conductors are covered with a thick coating of rubber and this is not a shock hazard but you may consider wrapping with electrical tape to help protect the wire and keep water from running down the wire and entering the panel.

7.0 Picture 1 wires frayed here

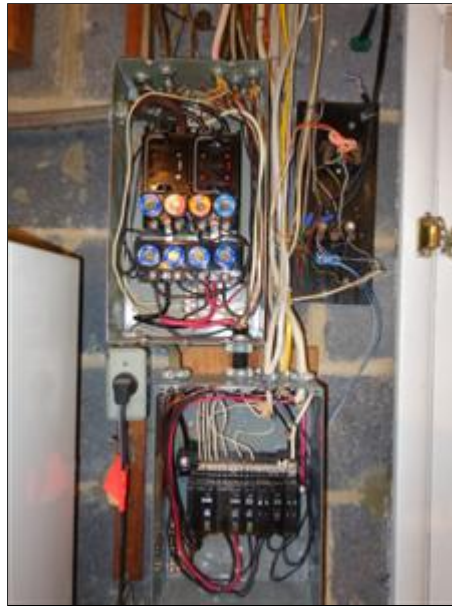
The breakers in this panel in several locations have two wires under one breaker screw. This condition is commonly referred to as a "double tap" The condition can lead to overloaded circuits but in and of itself does not necessarily mean a code violation exist. Seek a licensed electricians opinion and repair.

The main panel consist of no single main breaker as required in modern panels. Also it uses twist type fuses as opposed to modern breakers which can be reset if an overload occurs. I recommend having an electrician evaluate and install a modern 200 amp breaker type panel.

7.1 Picture 1 view of both panels

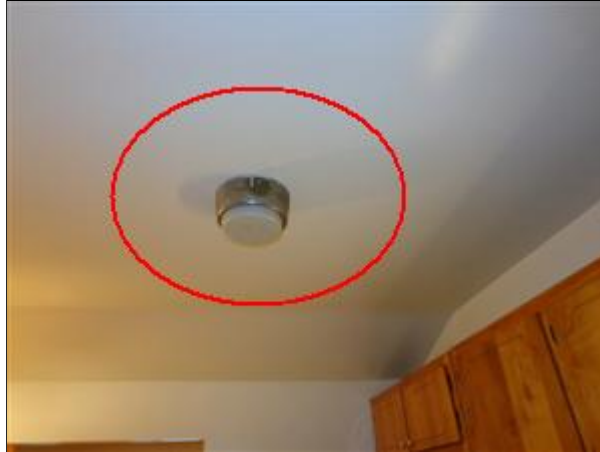
The kitchen light was not operational. This could be as simple fix (replace bulb) or a more serious issue requiring a licensed electrician. Have repaired replaced as needed.

7.3 Picture 1 light out

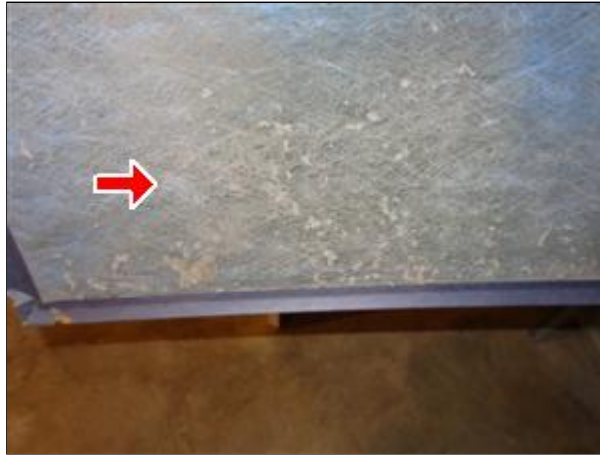
The 16x25 Filter is dirty and needs replacing in basement unit.

8.1 Picture 1 filter dirty

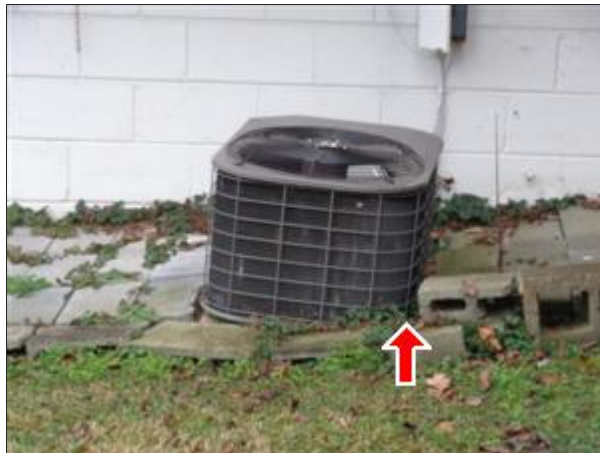
(2) The A/C unit is slightly out of level. Its recommended by the manufacturer that the unit be level since oil is stored in the bottom of the compressor. Level slab as needed by removing or adding dirt.

8.5 Picture 1 raise up

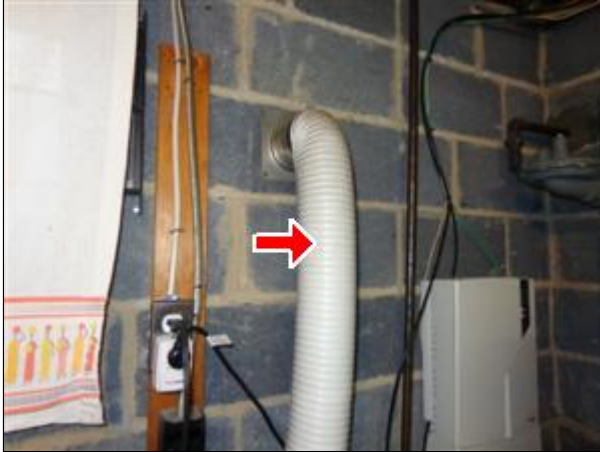
The gas clothes dryer vent is required to be made of metal with a smooth interior finish for proper venting. Currently a flex vent is being used which can trap lint and leak condensation and flue gases out of the vent. Consider replacing with a proper pipe.

9.2 Picture 1 flex vent

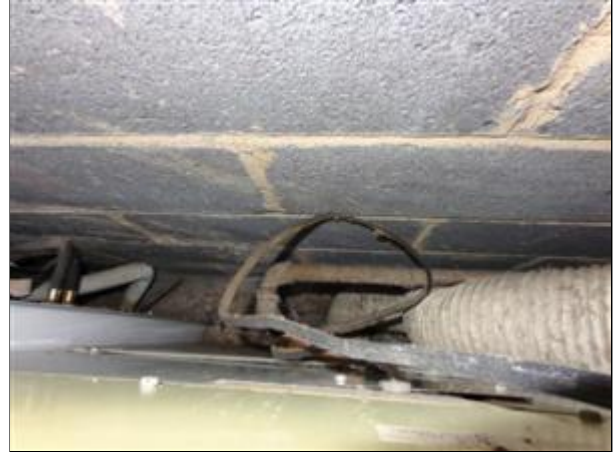
9.2 Picture 2 connection behind dryer
